DEPARTMENT OF TRANSPORTATION**DIVISION OF ENGINEERING SERVICES**

Quality Assurance and Source Inspection

Contract #: 04-0120F4Cty: SF/ALA Rte: 80 PM: 13.2/13.9File #: 1.28**WELDING INSPECTION REPORT****Resident Engineer:** Pursell, Gary**Address:** 333 Burma Road**City:** Oakland, CA 94607**Report No:** WIR-012666**Date Inspected:** 17-Mar-2010**Project Name:** SAS Superstructure**OSM Arrival Time:** 630**Prime Contractor:** American Bridge/Fluor Enterprises, a JV**OSM Departure Time:** 1500**Contractor:** American Bridge/Fluor Enterprises, a JV**Location:** Job Site

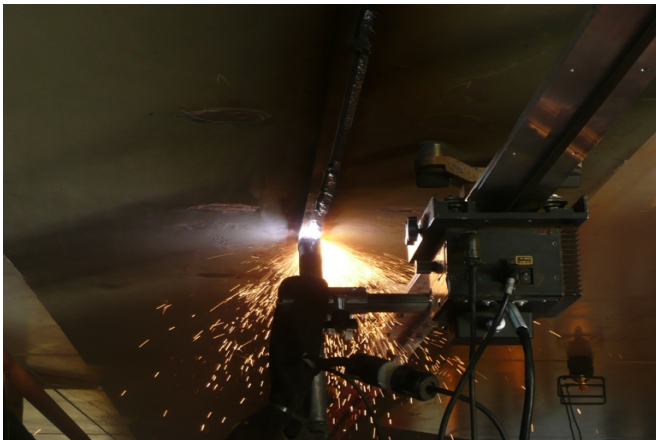
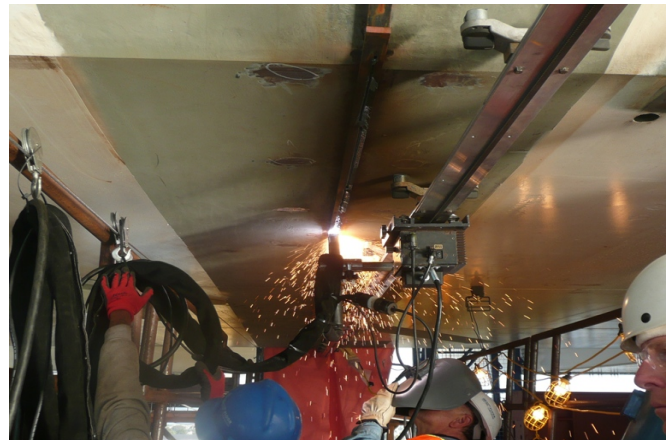
2E/3E-E-2

The QA Inspector randomly observed the ABF welders had previously started the induction heating blankets to ensure the minimum required preheat of 150°F was achieved prior to welding. The QA Inspector randomly verified utilizing a 150°F temperature indicating marker and noted the minimum required preheat had been achieved. The QA Inspector observed the ABF welder to be utilizing a semi automated FCAW track system for welding the above identified weld joint. The QA Inspector randomly observed the Smith Emery (SE) QC Inspector identified as Bernard Docena set the FCAW machine to the parameters of the approved WPS identified as ABF-WPS-D1.5-3042A-1. The QA Inspector randomly observed the FCAW parameters were 274 Amps, 21.7 Volts and a travel speed of 266mm/min. The QA Inspector randomly observed the ABF welder Jeremy Doleman continued the FCAW fill pass, once the semi automated track system reached a certain point the ABF welder Rory Hogan would observe the welding arc for the remainder of the weld. The QA Inspector noted the ABF welders did not complete the section of weld in C2 on the QA Inspectors shift.
